**Flood Control Project Maintenance
Levee Inspections**

Fall 2018 Levee Maintenance Deficiency Summary Report

Reclamation District No. 2095 Paradise Cut

Levee Inspection Report By Mile - Fall 2018

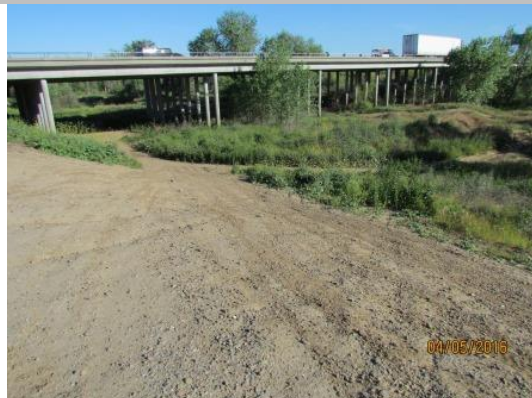
Photo 1 of 1 : FA_2018_RD2095_322_10_20180911_00001.jpg

LM Start	0.15	Rating **	A/W	Issue No.	10
LM End	0.15	Issue Type +	Ma	Location *	WS
Category	Earthen Levee			GPS Latitude/Longitude	
				Start	End
Item	Slope Stability			37.769997°	37.769997°
				-121.325055°	-121.325055°
DWR ID	DWR_RD2095_01_f_2015_10				
Comment Code					
S3 : Repair the levee slope damaged by vehicle traffic and prevent access where possible.					
Inspector Comment					
LMA is actively controlling access. The slope appears to be stable and should be monitored for possible erosion.

View of the vehicle tracks on the waterside levee slope.

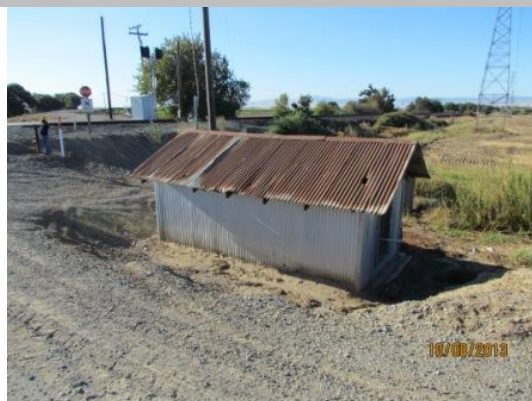
Photo 1 of 1 : FA_2018_RD2095_322_11_20180911_00002.jpg

LM Start	0.71	Rating **	M	Issue No.	11
LM End	0.71	Issue Type +	En	Location *	LS
Category	Earthen Levee			GPS Latitude/Longitude	
				Start	End
Item	Encroachments			37.763630 °	37.763630 °
				-121.319045 °	-121.319045 °
DWR ID	DWR_RD2095_01_s_2012_11				
Comment Code					
BU : Building					
Inspector Comment					
Pump house near RR.

View of building at the landside levee toe.

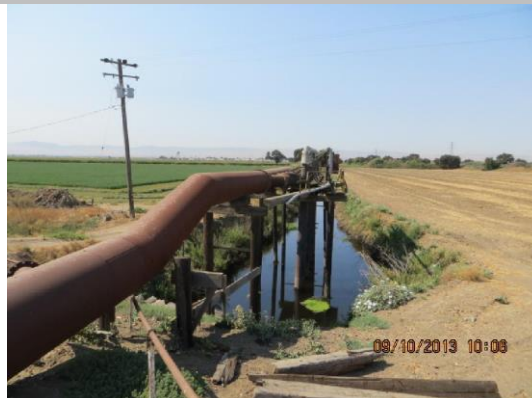
Photo 1 of 3 : UCIP_FA_2018_19812_33711.jpg

Comment Code						
Inspector Comment						
FS_ID:19812						
DS_ID:21637						
EP_NO: 13926						
Repair Type: Non-Urgent						
Crossing Status: Found						
UCIP Comments: No electrical connection can be identified. Possibly awaiting a flood event for re-activation.						
FIELD_STRUCT_DESC: 40-inch steel drainage discharge pipe through the levee, 1 foot below the crown. 6 pumps mounted on a wooden pier at the landside (LS) toe All the pumps discharge into a 40-inch pipe.						
Permit was for a 24-inch steel discharge pipe through the levee, 2 feet below the crown with a flap gate on the waterside (WS), but permit notes show it was modified in 2001 to its current status. (Permit No. 13926 - State of California, Department of Corrections [date not indicated in permit database]).						
FS Date: 9/10/2013

Pumps on pier at LS toe. Note electrical conduit without connection on right side of pier.

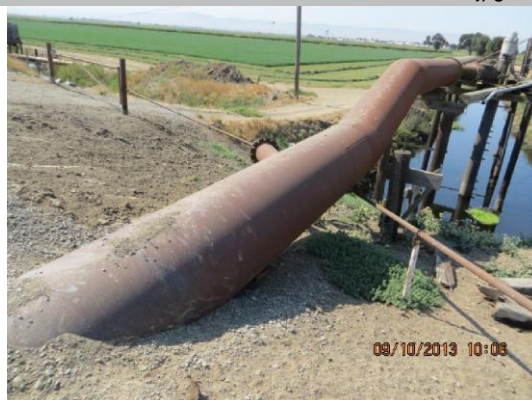
Photo 2 of 3 : UCIP_FA_2018_19812_33710.jpg

Pipe on LS slope.

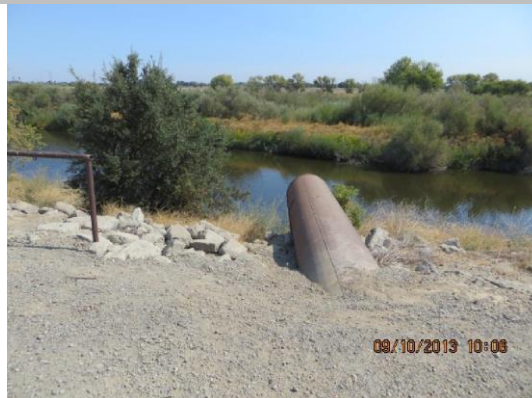
Photo 3 of 3 : UCIP_FA_2018_19812_33709.jpg

Pipe on WS shoulder.

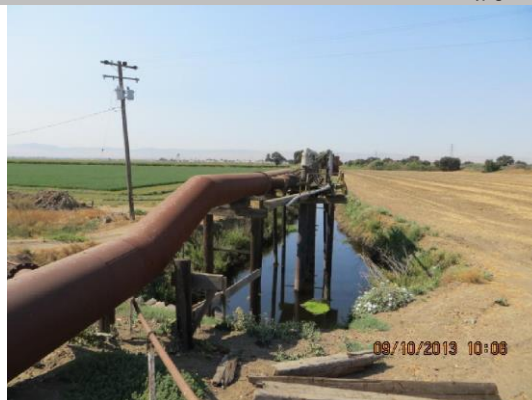
Photo 1 of 3 : UCIP_FA_2018_34387_62273.jpg

Comment Code						
Inspector Comment						
FS_ID:34387						
DS_ID:21629						
EP_NO: 6259						
Repair Type: Non-Urgent						
Crossing Status: Found						
UCIP Comments: What appears to be the concrete headwall on the LS toe is tilting and failing. There is a possibility that the concrete is rubble used to fill in around levee toe. Good candidate for video inspection.						
FIELD_STRUCT_DESC: 30-inch corrugated metal drainage pipe through the levee, 21 feet below the crown. Slide gate in riser on the waterside (WS) slope. Concrete headwalls and aprons on both ends. Flap gate on the WS end. Two corrugated metal cutoff walls. (Permit No. 6259, 1968 - Everett Farms). [Additional Reference(s): DWR Levee Log, 2005].						
FS Date: 9/10/2013

Pipe inlet located below 40-inch pipe at LS toe canal.

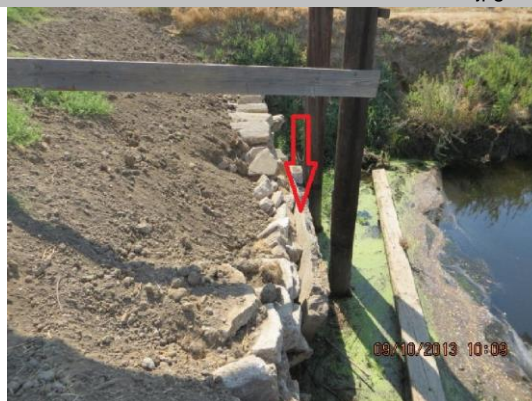
Photo 2 of 3 : UCIP_FA_2018_34387_62272.jpg

Comment Code						
Inspector Comment						
FS_ID:34387 DS_ID:21629 EP_NO: 6259 Repair Type: Non-Urgent Crossing Status: Found UCIP Comments: What appears to be the concrete headwall on the LS toe is tilting and failing. There is a possibility that the concrete is rubble used to fill in around levee toe. Good candidate for video inspection. FIELD_STRUCT_DESC: 30-inch corrugated metal drainage pipe through the levee, 21 feet below the crown. Slide gate in riser on the waterside (WS) slope. Concrete headwalls and aprons on both ends. Flap gate on the WS end. Two corrugated metal cutoff walls. (Permit No. 6259, 1968 - Everett Farms). [Additional Reference(s): DWR Levee Log, 2005]. FS Date: 9/10/2013

Concrete headwall on LS toe is tilting heavily towards canal.

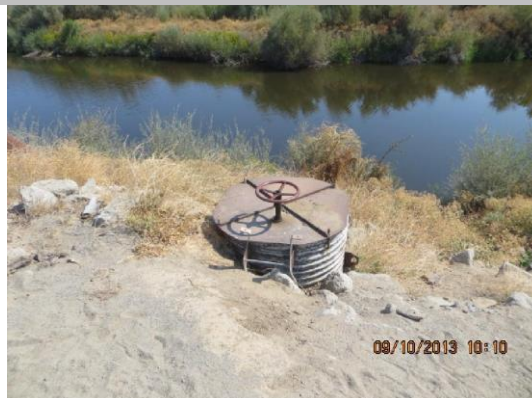
Photo 3 of 3 : UCIP_FA_2018_34387_62271.jpg

Slide gate in 48-inch CMP riser on WS shoulder.

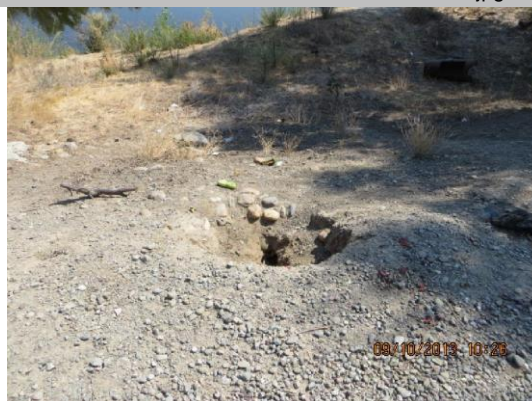
Photo 1 of 3 : UCIP_FA_2018_19815_33719.jpg

LM Start	0.91	Rating **	M	Issue No.	22	
LM End	0.91	Issue Type +	En	Location *		
Category	Supplemental			GPS Latitude/Longitude		
				Start		End
Item	DWR UCIP Field Study			37.761079 °		37.761079 °
				-121.317567 °		-121.317567 °
DWR ID	21630					
Comment Code						
Inspector Comment						
FS_ID:19815 DS_ID:21630 EP_NO: N/A Repair Type: Non-Urgent Crossing Status: Indicator Found UCIP Comments: Pipe abandoned and should be verified as having been done so properly. FIELD_STRUCT_DESC: *ABANDONED* 12-inch steel drainage pipe through the levee, 1.5 feet below the crown. Pump on pile structure in drainage ditch on the landside (LS). Siphon breaker in steel standpipe on the waterside (WS) slope. [Additional Reference(s): DWR Levee Log, 2005. USACE San Joaquin O&M Manual 10, March 1964, (HLM 0.92)]. FS Date: 9/10/2013

Hole on LS shoulder where standpipe may have been located.

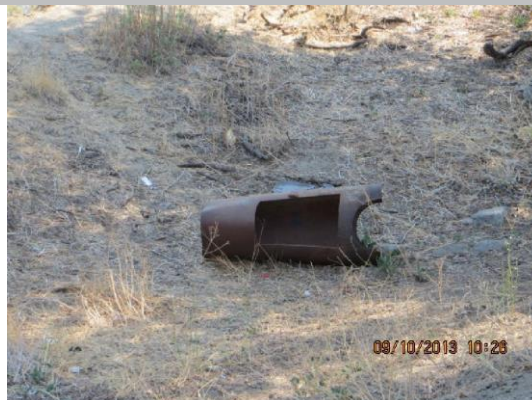
Photo 2 of 3 : UCIP_FA_2018_19815_33718.jpg

Standpipe discarded on WS berm.

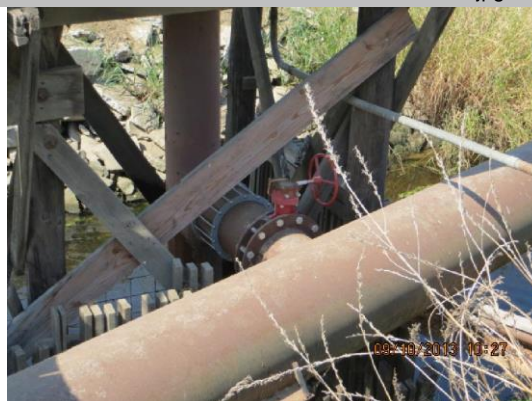
Photo 3 of 3 : UCIP_FA_2018_19815_33717.jpg

Possible location of 12-inch pipe connection to pump on LS toe.

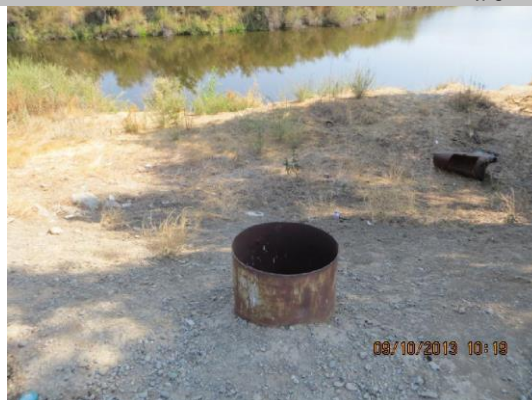
Photo 1 of 3 : UCIP_FA_2018_19813_33715.jpg

Comment Code						
Inspector Comment						
FS_ID:19813						
DS_ID:21631						
EP_NO: 6537						
Repair Type: Non-Urgent						
Crossing Status: Found						
UCIP Comments: Corroded holes on pipe at outlet WS toe, good indication of internal pipe condition. Good candidate for video inspection.						
FIELD_STRUCT_DESC: 14-inch steel drainage discharge pipe through the levee, 2.5 feet below the crown. Pump on pile structure in drainage ditch on the landside (LS). Siphon breaker in 24-inch corrugated metal pipe (CMP) riser on the waterside (WS) shoulder. Flap gate on the WS end. (Permit No. 6537, 1969 - Everett Farms). [Additional Reference(s): DWR Levee Log, 2005].						
FS Date: 9/10/2013

Siphon Breaker/vent in 24-inch steel riser on WS shoulder.

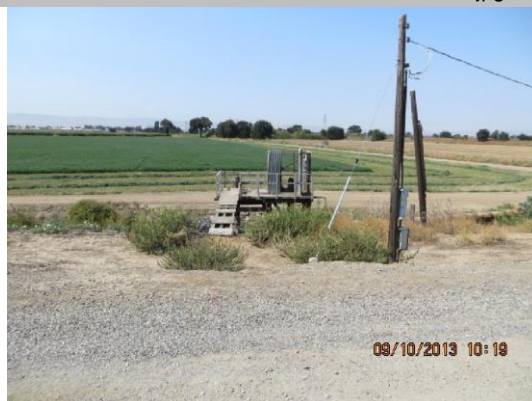
Photo 2 of 3 : UCIP_FA_2018_19813_33714.jpg

Pump on wooden pier at LS toe.

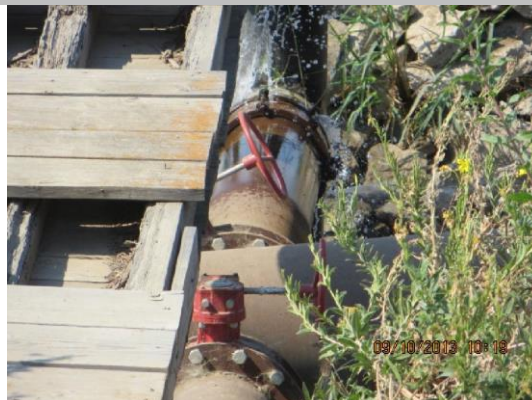
Photo 3 of 3 : UCIP_FA_2018_19813_33713.jpg

Butterfly valve at pump on LS toe.

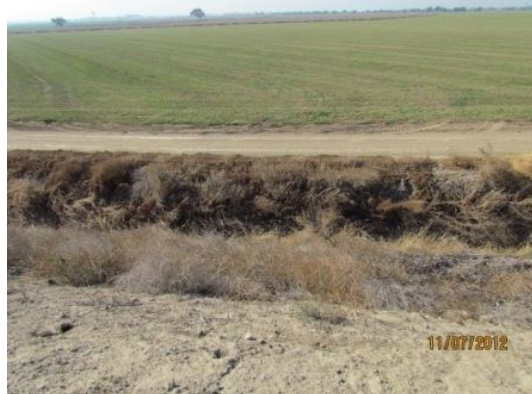
Photo 1 of 1 : FA_2018_RD2095_323_5_20180911_00006.jpg

LM Start	0.36	Rating **	M	Issue No.	5
LM End	0.82	Issue Type +	En	Location *	LS
Category	Earthen Levee			GPS Latitude/Longitude	
				Start	End
Item	Encroachments			37.754952 °	37.749645 °
				-121.305880 °	-121.301977 °
DWR ID	DWR_RD2095_02_f_2012_5				
Comment Code					
DT : Ditch					
Inspector Comment

View of a ditch along the landside toe.

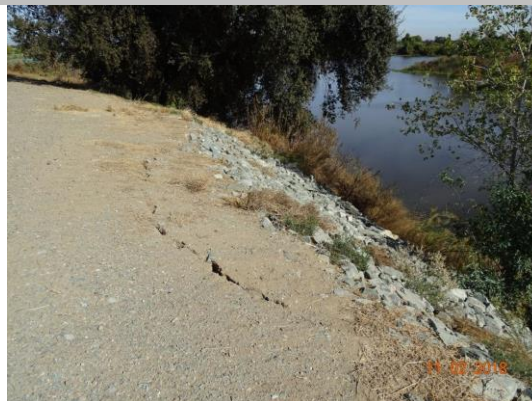
Photo 1 of 1 : FA_2018_RD2095_323_10_20181105_00020.jpg

LM Start	1.33	Rating **	M	Issue No.	10
LM End	1.33	Issue Type +	Ma	Location *	WS
Category	Earthen Levee			GPS Latitude/Longitude	
				Start	End
Item	Cracking			37.744904 °	37.744904 °
				-121.297679 °	-121.297679 °
DWR ID	DWR_RD2095_02_f_2018_10				
Comment Code					
CR1 : Monitor and have inspected by geotechnical engineer.					
Inspector Comment					
Large crack on the waterside shoulder at previous erosion repair site. Recommend getting a geotechnical engineer to evaluate the crack.

View of cracking on waterside shoulder. Fall 2018.

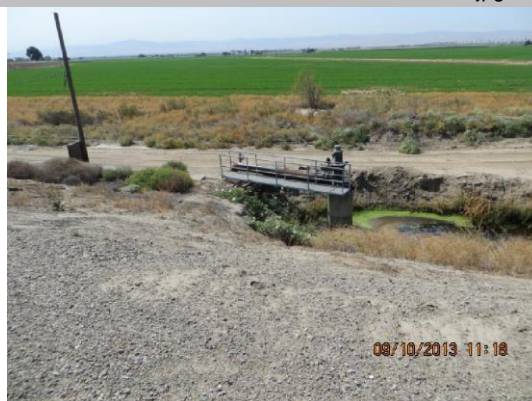
Photo 1 of 1 : UCIP_FA_2018_19863_33760.jpg

LM Start	1.48	Rating **	M	Issue No.	942
LM End	1.48	Issue Type +	En	Location *	
Category	Supplemental			GPS Latitude/Longitude	
				Start	End
Item	DWR UCIP Field Study			37.743142 °	37.743142 °
				-121.297692 °	-121.297692 °
DWR ID	21642				
Comment Code					
Inspector Comment					
FS_ID:19863 DS_ID:21642 EP_NO: 4658 Repair Type: Non-Urgent Crossing Status: Found UCIP Comments: Pipe appears abandoned in place and re-routed to LM 1.652. Need to verify pipe was properly abandoned. Permit FIELD_STRUCT_DESC: *ABANDONED* 14-inch steel drainage pipe through the levee, 3.5 feet below the crown. Pump on structure over drainage ditch on the landside (LS). Flap gate on the waterside (WS) end. (Permit No. 4658, 1964 - Cochran Company, Inc.). [Additional Reference(s): DWR Levee Log, 2005. USACE San Joaquin O&M Manual 11, 1968, (HLM 1.51)]. FS Date: 9/10/2013

Pump visible on LS toe, but pipe has been re-routed to southwest.

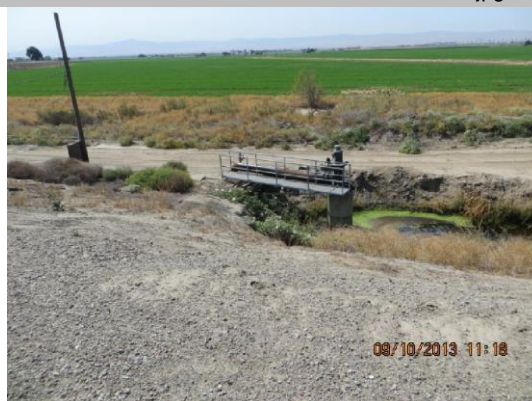
Photo 1 of 3 : UCIP_FA_2018_19866_33767.jpg

LM Start	1.63	Rating **	M	Issue No.	943
LM End	1.63	Issue Type +	En	Location *	
Category	Supplemental			GPS Latitude/Longitude	
				Start	End
Item	DWR UCIP Field Study			37.741345 °	37.741345 °
				-121.296189 °	-121.296189 °
DWR ID	21654				
Comment Code					
Inspector Comment					
FS_ID:19866 DS_ID:21654 EP_NO: 6298A Repair Type: Non-Urgent Crossing Status: Found UCIP Comments: No permit identified for this crossing. FIELD_STRUCT_DESC: 16-inch steel drainage pipe through the levee 2-feet below the crown. Siphon breaker in PVC riser on WS shoulder. Pump on pier in ditch on LS toe 750-feet to Northwest from crossing. FS Date: 9/10/2013

Pump located at levee toe 750-feet north west of pipe crossing.

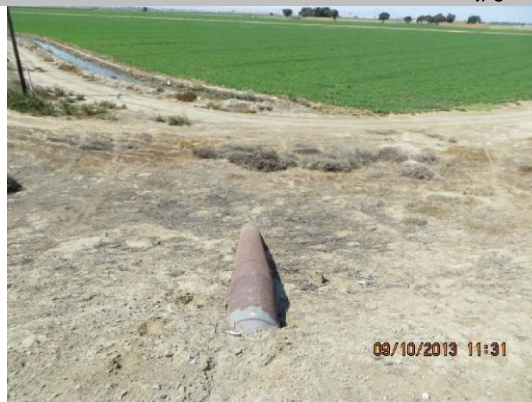
Photo 2 of 3 : UCIP_FA_2018_19866_33766.jpg

16-inch steel pipe on LS slope.

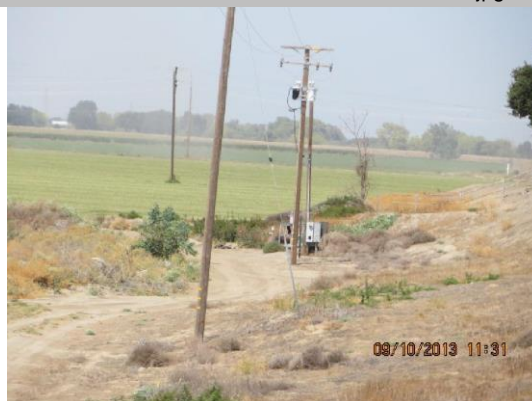
Photo 3 of 3 : UCIP_FA_2018_19866_33765.jpg

Pump located at levee toe 750-feet north west of pipe crossing.

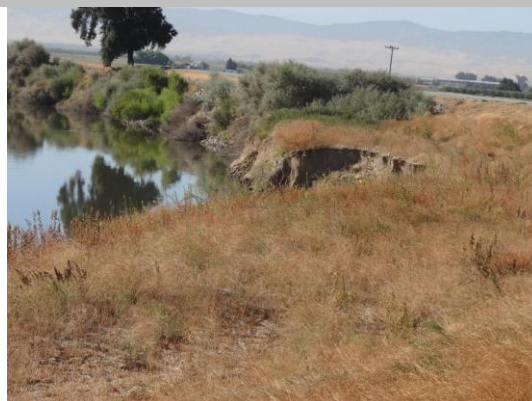
Photo 1 of 4 : FA_2018_RD2095_323_1_20180911_00001.jpg

9/29/2009: Site is immediately downstream of a section of existing rip rap; there is a 20-foot berm remaining; berm will continue to erode unless erosion is mitigated; Site# is the same as RM62.6, LM1.87; recommended for annual assessment, per CES Evaluation 2008 Report 2006: Visited 10/20/06 [2017 Site ID:RD2095U02RM60.62]

Looking at the erosion from downstream.

9/22/2010: No significant change observed. There is moderate vegetation growth on the berm. Despite the erosion occurring on the berm, corrective action should be taken before the issue becomes severe.

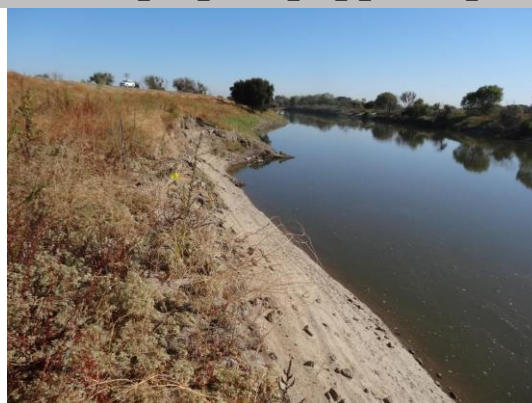
Photo 2 of 4 : FA_2018_RD2095_323_1_20180911_00002.jpg

Looking at the erosion from upstream.

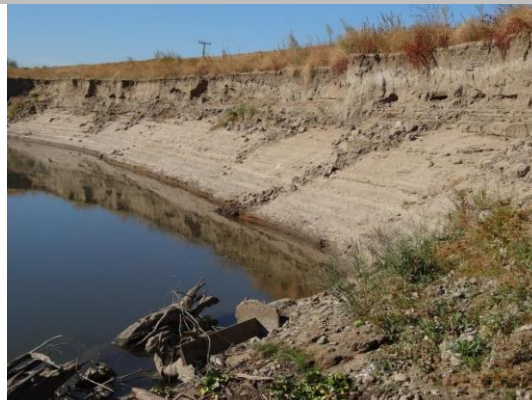
Photo 3 of 4 : FA_2018_RD2095_323_1_20180911_00003.jpg

Close view of the erosion.

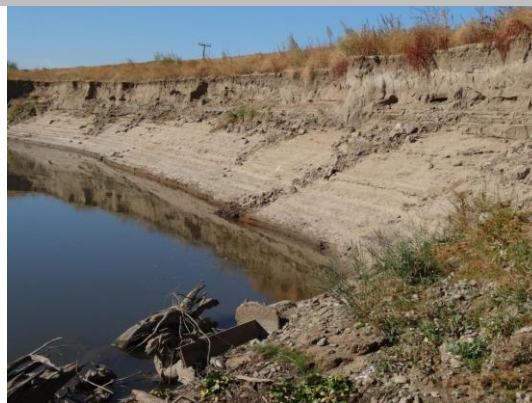
Photo 4 of 4 : FA_2018_RD2095_323_1_20180911_00004.jpg

Close view of the erosion.

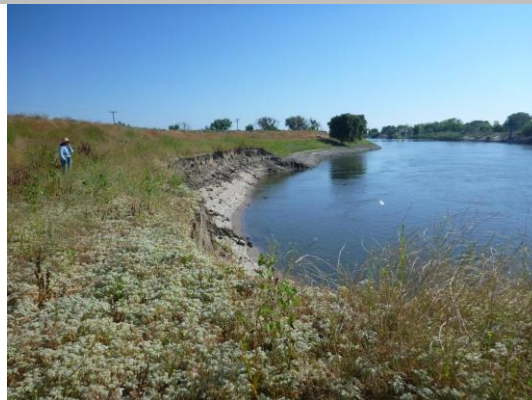
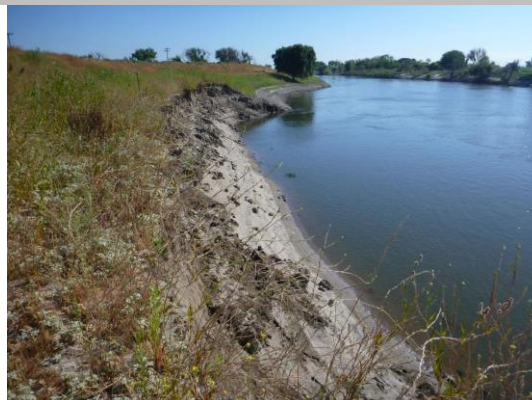
Description: Active waterside erosion on San Joaquin River near the end of Wright Road in Tracy, CA. Total length of erosion extends 615. Erosion has extended 15 feet towards levee toe this flood season. Please see attached map and photos. As the high water level recedes from the winter storm, we can see more damage to this site. Erosion is active.

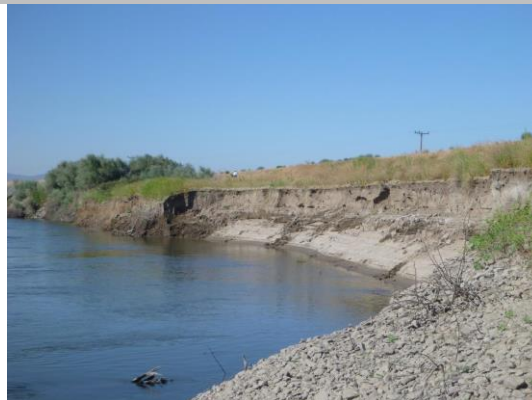
Photo 3 of 3 : LEVAL_FA_2018_469_2353.jpg

Comment Code						
Inspector Comment						
Levee Evaluation Comments						
Description:Active waterside erosion on san joaquin river near the end of Wright Road in Tracy, CA. Total length of erosion extends 615. Erosion has extended 15 feet towards levee toe this flood season. Pleasee see attached map and photots. As the high water level receds from the winter storm, we can see more damage to this stie. Erosion is active.						
Site ID No:469						
Site Designation:LMA-296						
Repair Type: Erosion						
Rating:Serious						
Field Date:7/26/2017						
Notes: This is an active erosion site. Zero vegetation within the eroded portion. It may not be quite in the prism now, but lost about 20 ft (horizontally) of bank last year. Saw eddies in the water here also.

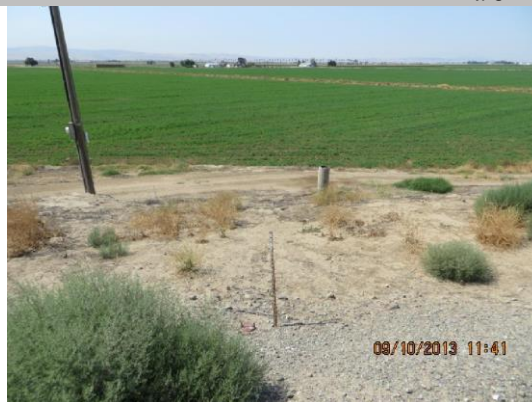
Photo 1 of 3 : UCIP_FA_2018_19867_33771.jpg

LM Start	2.08	Rating **	M	Issue No.	944
LM End	2.08	Issue Type +	En	Location *	
Category	Supplemental			GPS Latitude/Longitude	
				Start	End
Item	DWR UCIP Field Study			37.735416 °	37.735416 °
				-121.297860 °	-121.297860 °
DWR ID	21643				
Comment Code					
Inspector Comment					
FS_ID:19867					
DS_ID:21643					
EP_NO: N/A					
Repair Type: Non-Urgent					
Crossing Status: Found					
UCIP Comments: Siphon breaker on LS shoulder does not appear to be functional.					
FIELD_STRUCT_DESC: 16-inch steel irrigation pipe through the levee, 2 feet below the crown. Slant pump on steel platform on the waterside (WS) slope. Siphon breaker on the landside (LS) shoulder marked by a T-post. Service pole and meter on the LS toe. Possible concrete standpipe on the LS toe. [Additional Reference(s): DWR Levee Log, 2005. USACE San Joaquin O&M Manual 11, 1968, (HLM 2.12)].					
FS Date: 9/10/2013

Siphon breaker on LS shoulder next to T-post with Power pole and concrete standpipe on LS toe.

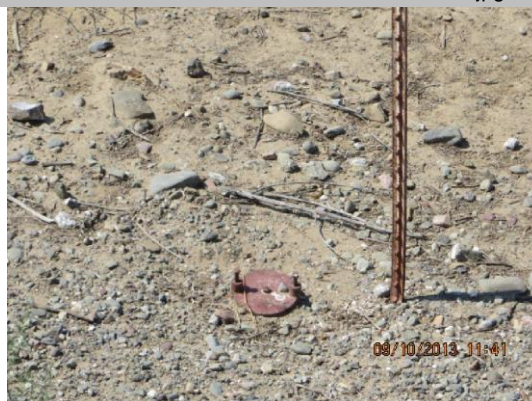
Photo 2 of 3 : UCIP_FA_2018_19867_33770.jpg

Siphon breaker on LS shoulder next to T-post.

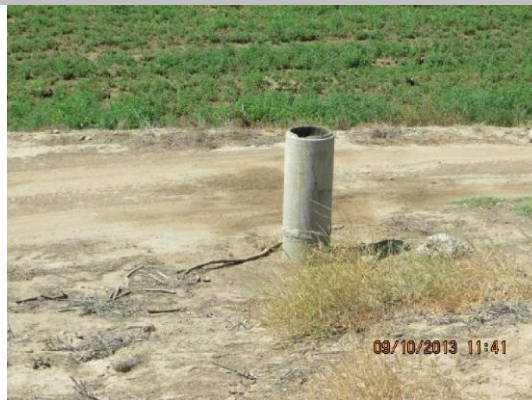
Photo 3 of 3 : UCIP_FA_2018_19867_33769.jpg

Concrete standpipe on LS toe.

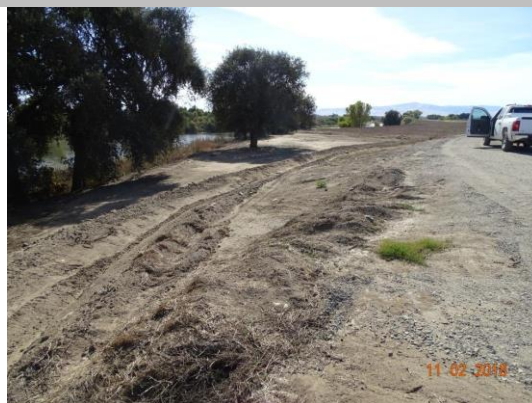
Photo 1 of 1 : FA_2018_RD2095_323_11_20181105_00021.jpg

View of ditch within landside easement. Fall 2018.

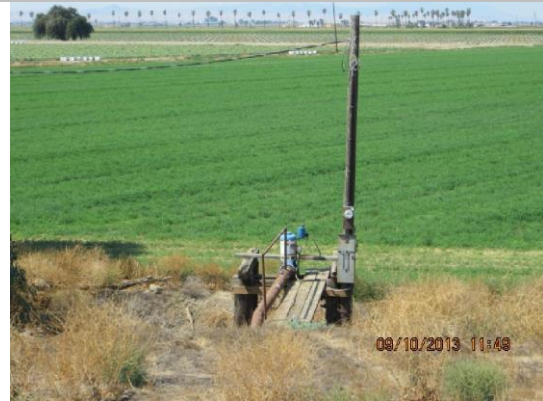
Photo 1 of 2 : UCIP_FA_2018_19871_33778.jpg

LM Start	2.38	Rating **	A/W	Issue No.	945
LM End	2.38	Issue Type +	Ma	Location *	
Category	Supplemental			GPS Latitude/Longitude	
				Start	End
Item	DWR UCIP LMA Responsibility			37.731313°	37.731313°
				-121.298298°	-121.298298°
DWR ID	21644				
Comment Code					
Inspector Comment					
FS_ID:19871					
DS_ID:21644					
EP_NO: N/A					
Repair Type: No Action Needed					
Crossing Status: Found					
UCIP Comments:					
FIELD_STRUCT_DESC: 8-inch steel drainage pipe through the levee, 3 feet below the crown. Pump in drainage ditch on the landside (LS). Vent pipe at the waterside (WS) toe. 1.5-inch galvanized iron electrical conduit through the levee at the same location. Service pole with a switch box and meter on the LS. [Additional Reference(s): DWR Levee Log, 2005. USACE San Joaquin O&M Manual 11, 1968, (HLM 2.41)].					
FS Date: 9/10/2013

Pump on metal pier off LS toe.

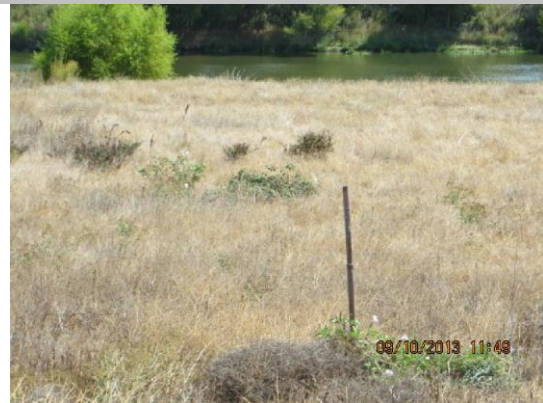
Photo 2 of 2 : UCIP_FA_2018_19871_33777.jpg

Vent standpipe on WS toe.
